# Capital Needs Assessment

Clark School

Amherst, NH

May 31, 2017

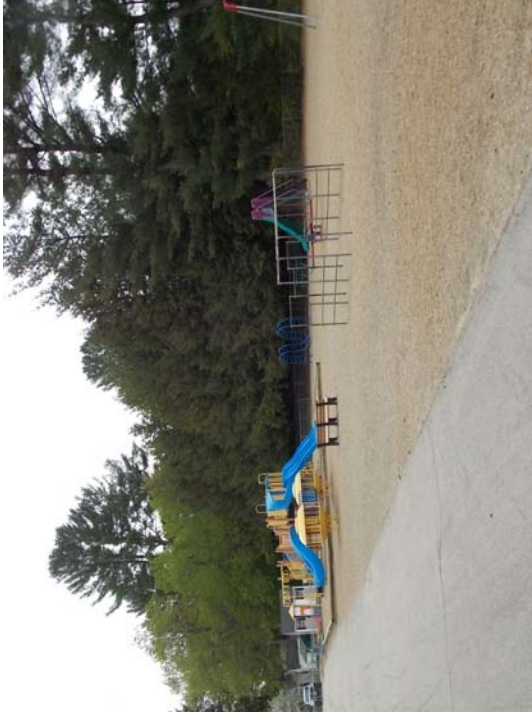
The play area is located behind the building and sits on a pea-stone base.

3. The play equipment is to be replaced in Year 10. Interlocking rubber mats should be considered as the base for the play equipment to replace the existing pea-stone base. Also shown in Year 10 is the cost for future servicing to the septic system and leaching field. The landscaping is to be upgraded in Year 12 and the chain link fence is to be replaced toward the end of the plan in Year 17.

| Play Equipment | 1 ls | 35000.00 | \$35,000 | 10 | 20 | 10 in 1 Year | Metal and high impact plastic equipment.<br>Replace in Yr 10; consider interlocking rubber mat base. |

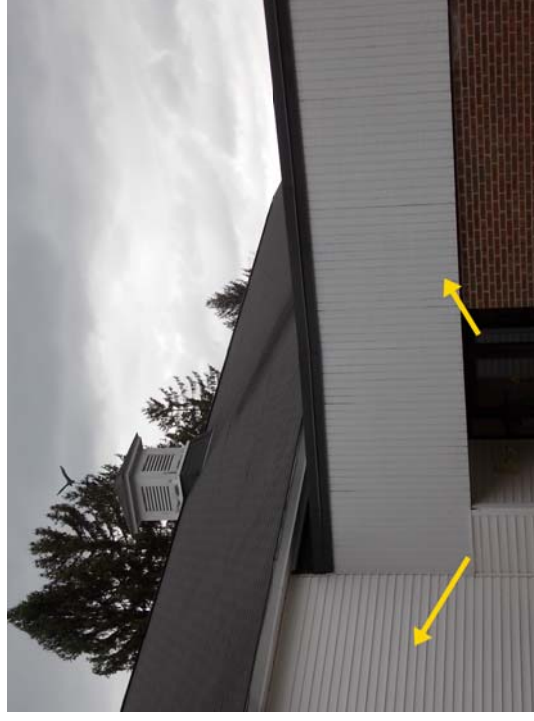
The building is clad with vinyl (left arrow), T1-11 (right arrow) and brick.

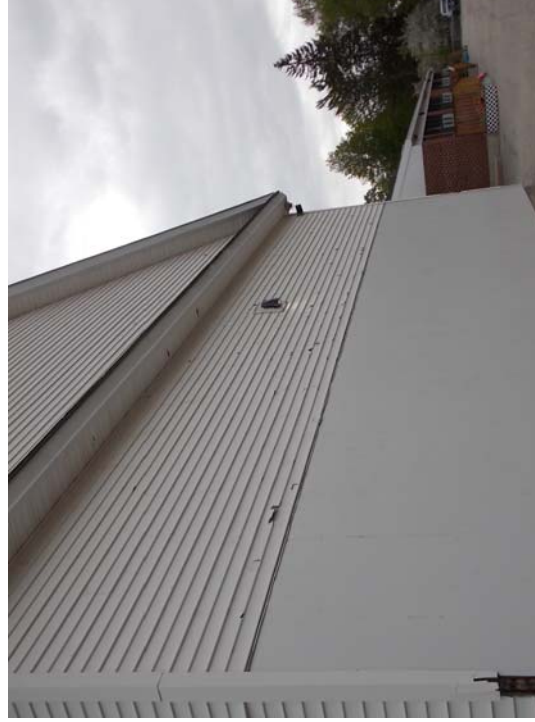
13. The vinyl siding, especially on the new building wing has a number of areas damaged by impact. Also, the T1-11 siding is showing signs of initial deterioration. The plan includes the costs to replace these existing building siding materials with a cementitious fiberboard product in Year 1, which will provided a more resilient and effective exterior wall finish than either the vinyl or T1-11. The brickwork appears to be in good condition and future repointing is shown in Year 16.
14. An allowance for anticipated failed window glazing replacement is shown starting in Year 12. Replacement of the service doors is shown in Year 18 and the secondary doors (classrooms and hallway) in Year 20.

The vinyl siding on the newer building wing has areas of impact damage.

| Replacement Items | Quantity | Cost per unit<br>in 2018 \$\$ | Total Cost<br>in 2018 \$\$ | AGE<br>(Years) | EUL<br>(Years) | Year of action AND duration of project | Notes |
|---|---|---|---|---|---|---|---|
| Exterior Walls - Vinyl | 10,500 sf | 7.15 | \$75,075 | 23 | 60 | 1 in 1 Year | Significant impact damage on new building wing. Replace<br>w/cement fiberboard product in Year 1. <b>Discuss</b> |

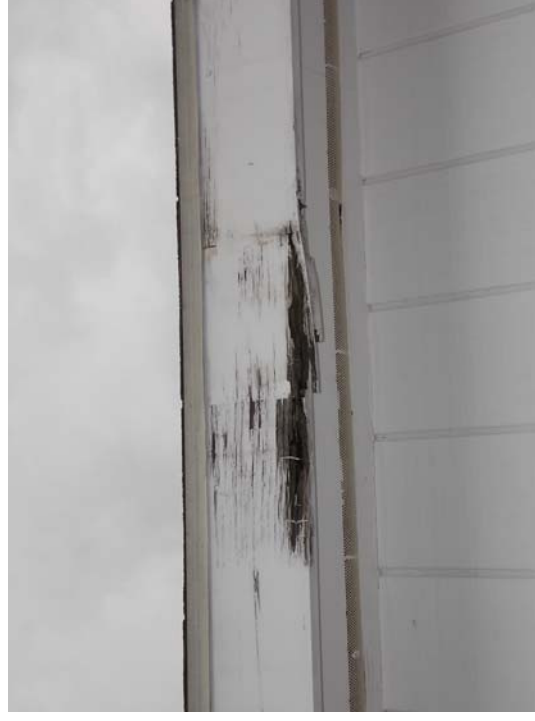
A close-up of deteriorating wood trim above the T1-11 siding.

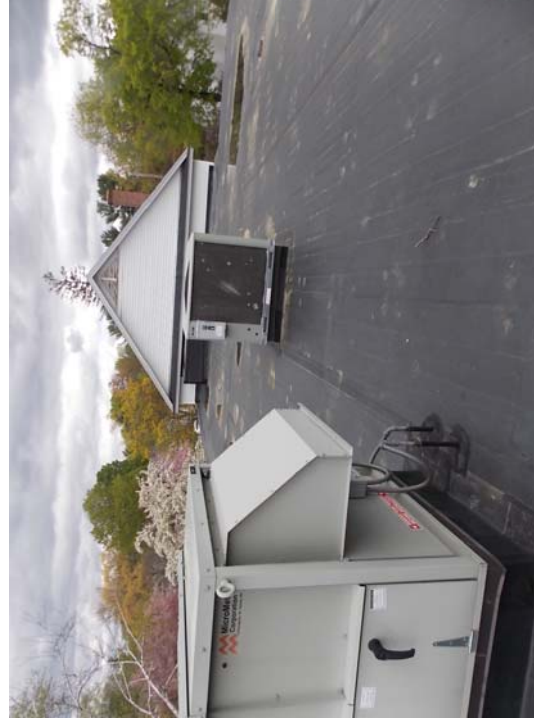
A view of the rubber membrane roofing (over the main portion of the school and several rooftop units. In the background is the original building wing.

16. The plan includes the cost to reseal the seams of the rubber membrane in Year 10, to help extend the roof covering's useful life; the cost to replace the membrane is shown in Year 16. The architectural shingles are also to be replaced in Year 20.

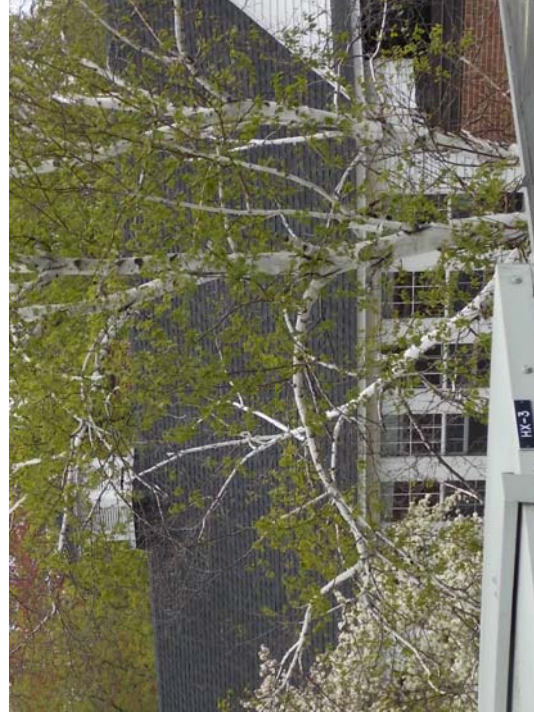
The pitched roof of the original building is covered with architectural shingles (which is also used on the other pitched roofs).

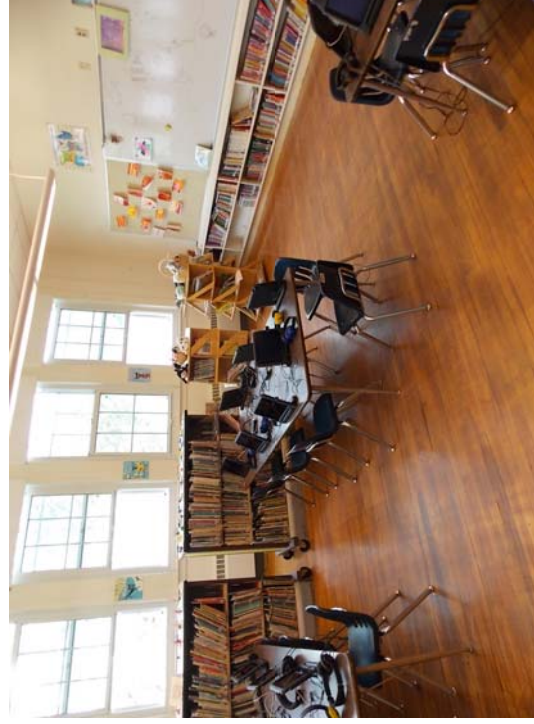
21. The concern about overheating in the library was discussed during the assessment. The overheating could be the result of standby heat that is being transferred from the hydronic heat distribution piping that runs under this space. One possible solution is to add, in Year 1, a thermostat-controlled variable speed exhaust fan. This fan would operate in a slow continuous mode until space temperatures exceed the predetermined temperature setting; at which point the fan speed increases to effectively vent the higher temperatures. This item should be discussed at the client review meeting.

A view of the library located on the upper floor of the original building wing.

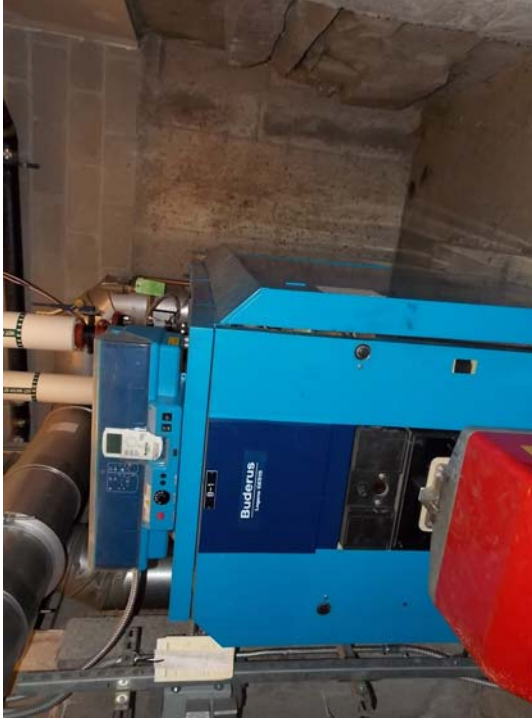
This is the new oil-fired boiler.

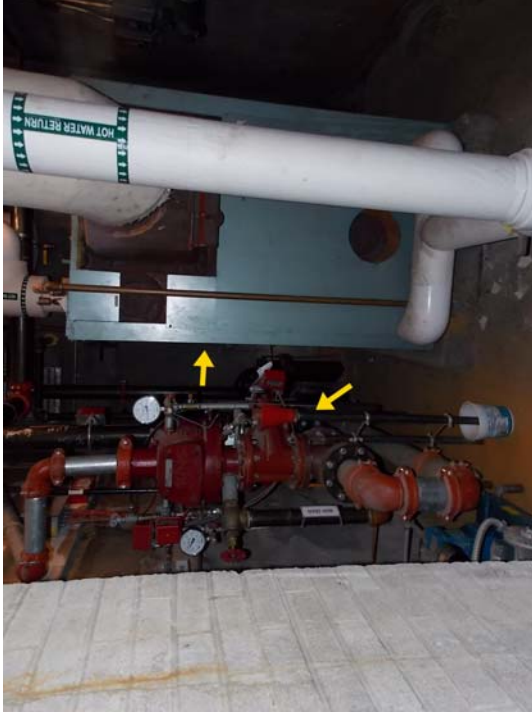
The original oil-fired boiler is on the right and the fire sprinkler connection is on the left.

| Replacement Items | Quantity | Cost per unit<br>in 2018 \$\$ | Total Cost<br>in 2018 \$\$ | AGE<br>(Years) | EUL<br>(Years) | Replacement Schedule<br>Year of action AND duration of project | Notes |
|---|---|---|---|---|---|---|---|
| Boiler - Original | 1 ea | 36960.00 | \$36,960 | 23 | 30 | 7 | HB Smith sectional, redundant source for heating<br>Replace in Year 7 |

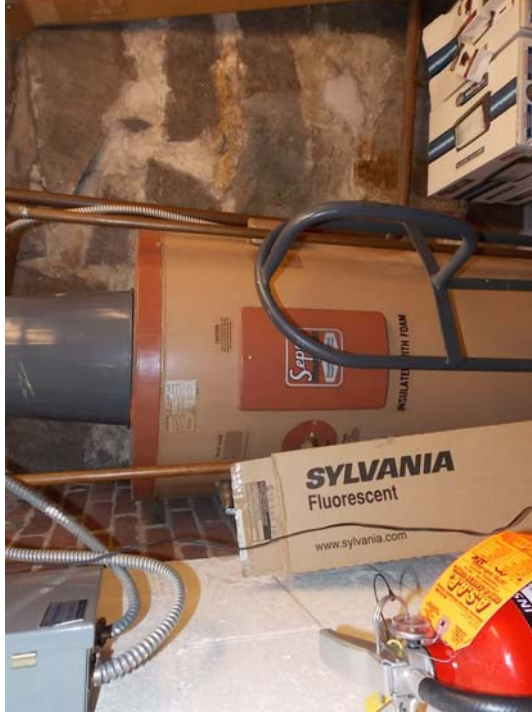
This 80-gallon electric heated DHW tank serves the entire facility.

| Replacement Items | Quantity | Cost per unit<br>in 2018 \$\$ | Total Cost<br>in 2018 \$\$ | AGE<br>(Years) | EUL<br>(Years) | Replacement Schedule<br>Year of action AND duration of project | Notes |
|---|---|---|---|---|---|---|---|
| DHW Generation | 1 ea | 7100.00 | \$7,100 | 8 | 12 | 4 /16 | Electric-heated SEPCO 80-gallon tank<br>Replace in Years 4 and 16 |

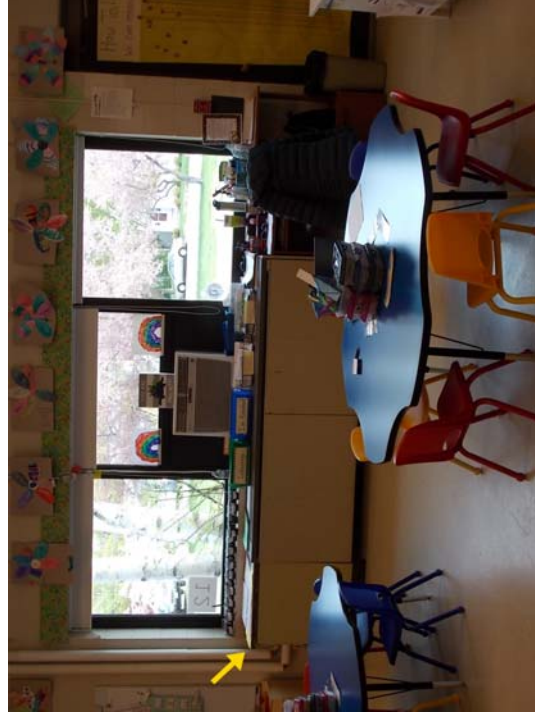
This classroom has a through-wall convector (arrow) to provide heating and fresh air ventilation.

| Replacement Items | Quantity | Cost per unit<br>in 2018 \$\$ | Total Cost<br>in 2018 \$\$ | AGE<br>(Years) | EUL<br>(Years) | Notes |
|---|---|---|---|---|---|---|
| Convectors | 1 ls | 11250.00 | \$11,250 | Varies | 20 | Wall and ceiling mounted units<br>Repair allowance |
