Capital Needs Assessment

Wilkins Elementary School

June 1, 2017

Preliminary Report

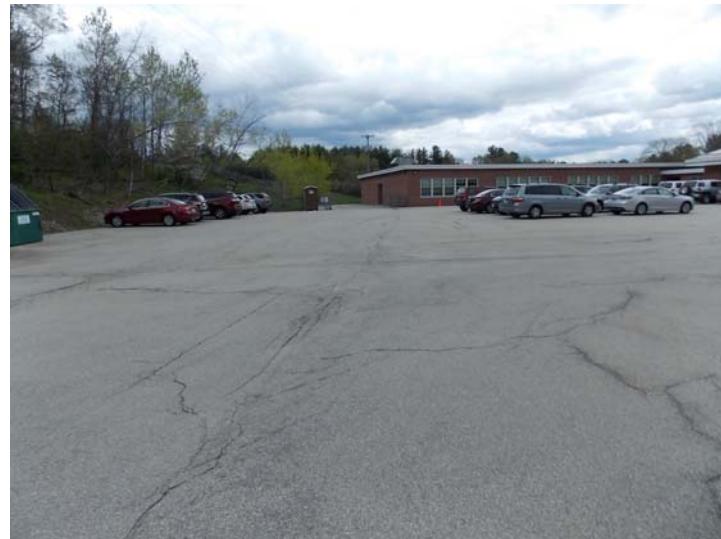
A view of cracks in the asphalt paving.

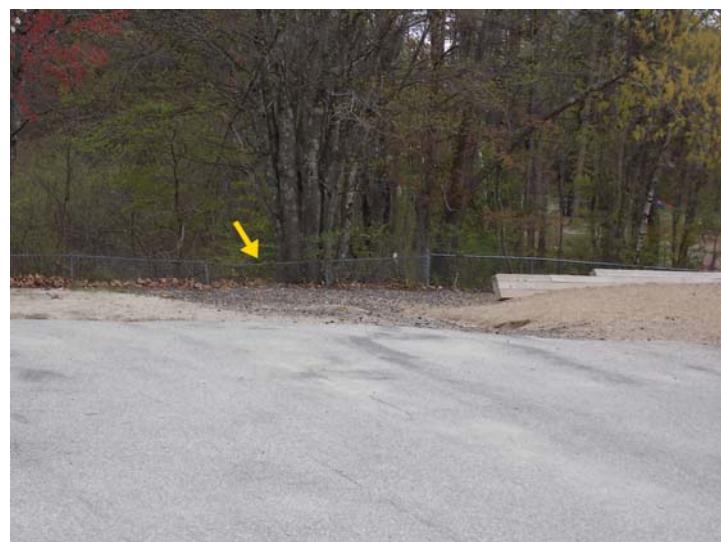
2. There is significant erosion at the play area that has destabilized a retaining wall and has covered the majority of a surrounding chain link fence. The plan includes an allowance in Year 1 to address the erosion, including re-grading the land, and possibly using open grid pavers to improve and control drainage in this area. This cost also includes repairing the retaining wall. The chain link fence repair is shown concurrent to this landscaping effort.
3. The parking lots, driveways, and walkways have areas that are isolated cracks. The cost to repair these surfaces (crack-fill, sealcoat, and re-stripe) is shown in Years 2, 7, and 12; resurfacing is shown in Year 17.
4. The play equipment is to be replaced in Year 10. The plan also includes the cost for future servicing to the septic system and leaching field, in Year 10.

The height of the perimeter fence has been reduced by almost 50% due to the erosion at the playground.

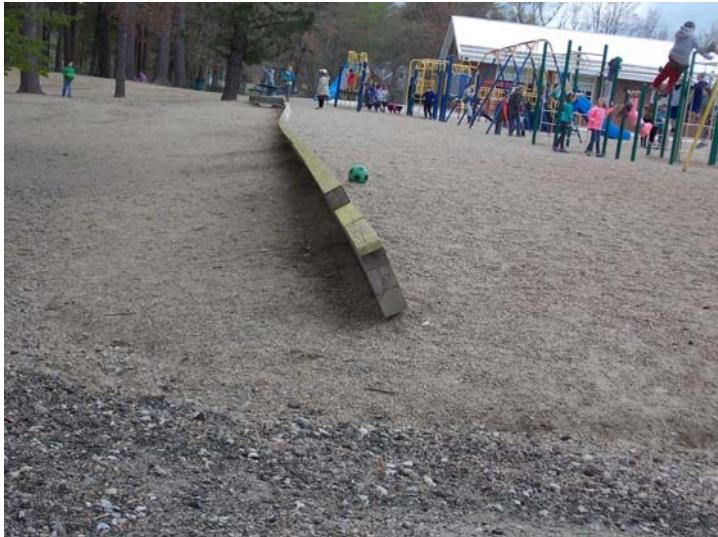
This retaining wall is no longer upright and needs to be addressed in the near term.

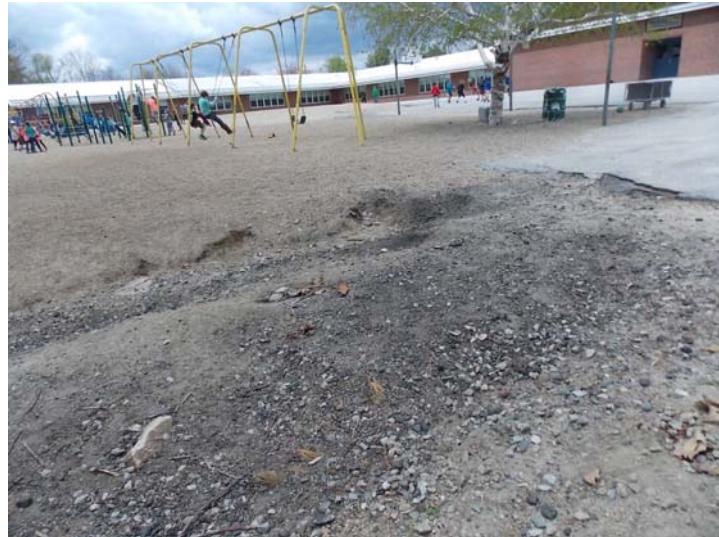
An eroded area at the edge of the playground.

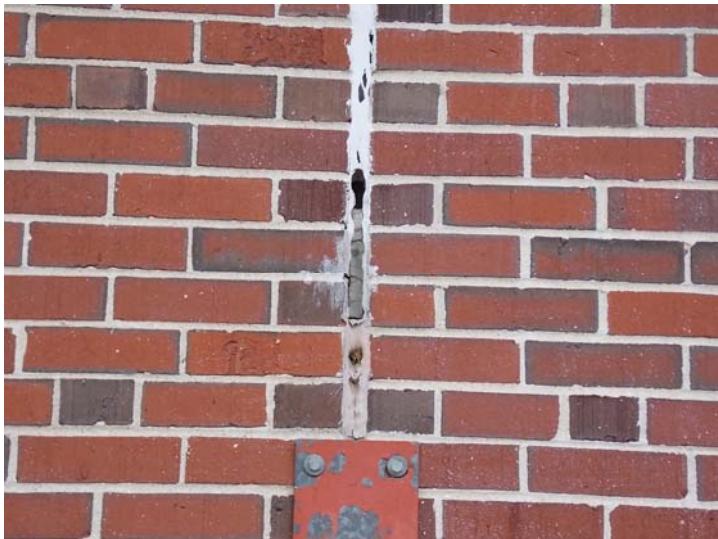
13. The cost to replace the caulking, in which there were sections found to be dried, cracked, and in some isolated areas voids were also noted, is shown in Years 1 and 16. The wood trim (fascia boards and soffits) are to be repaired and repainted in Years 1, 8, and 15. The shed that is attached to the main building clad with plywood, which is starting to deteriorate. The plan includes the cost to replace the plywood with a cementitious fiberboard product in Year 1. The brickwork appears to be in good condition and future repointing is shown in Year 16. The vinyl siding is to be power washed every six years starting in Year 4.

A building control joint that has dried and open caulking.

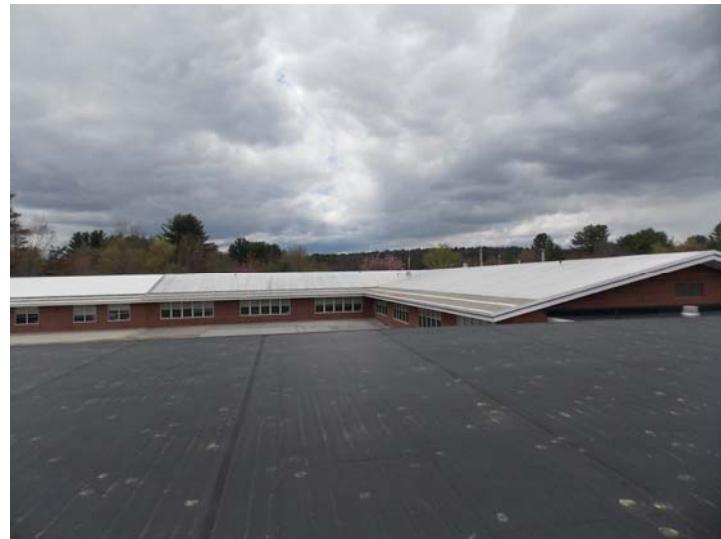
16. Overall, the roof coverings appear to be in good condition. The PVC membrane is to be replaced over a two-year period starting in Year 12. The rubber membrane is to be replaced in Year 14 preferably with a PVC membrane, which will provide a cooling benefit to the building during the summer months. The architectural shingles are to be replaced in Year 15.

On the main building, the flat roof is covered with a rubber membrane and the pitched roof is covered with a PVC membrane.

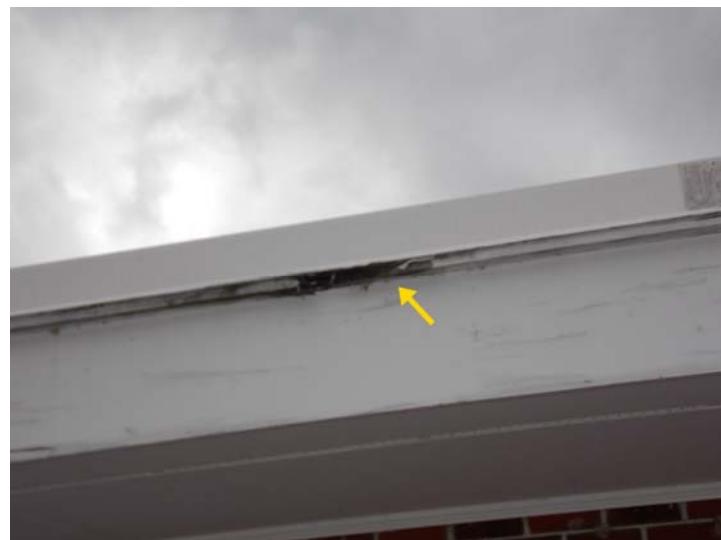
A close-up of damage at the top of a fascia board (wood trim near the roof line of the main building).

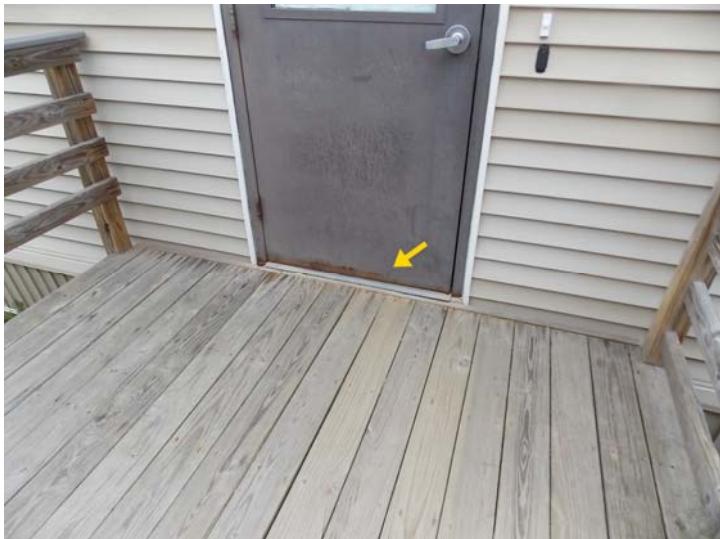
An exterior door on one of the portable buildings; note the rust at the bottom of the door.

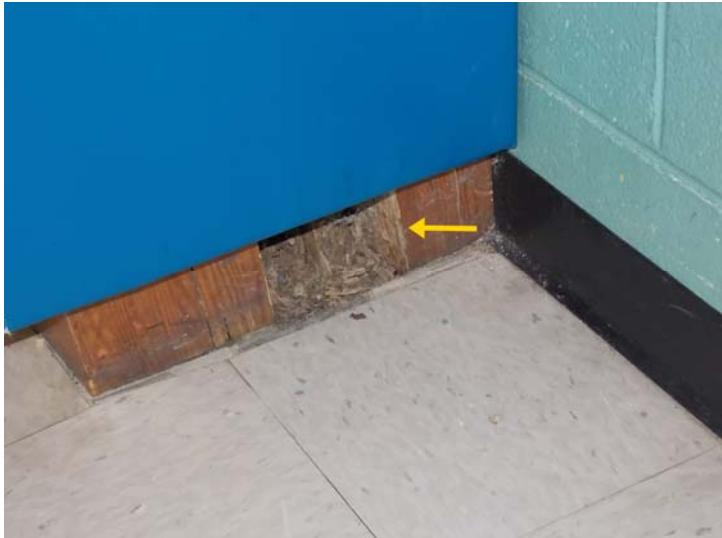
A close-up of previous termite damage. Maintenance continues to monitor the building any signs of reoccurrence.

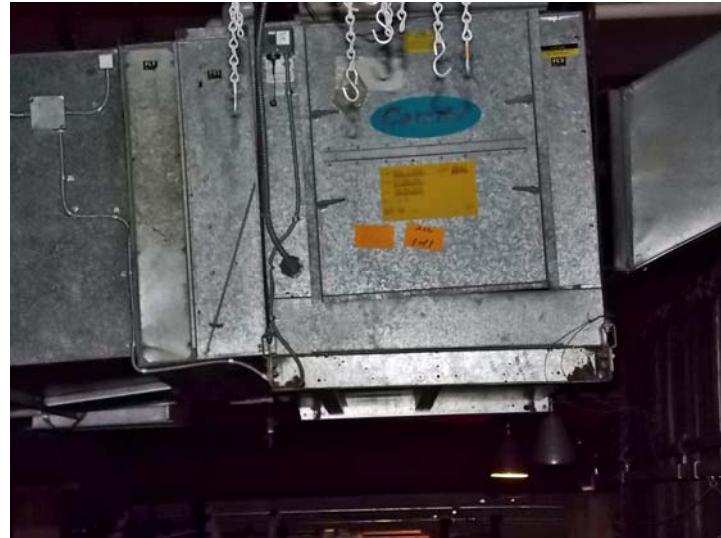
This air handler serves the Multipurpose Room.

10. The ceiling mounted air handler that serves the Multipurpose Room is to be upgraded (heating coil, controls, blower motor, etc.) in Year 5. The split direct expansion (DX) air conditioners are to be replaced in Year 10. The plan also anticipates replacing damaged finned tube radiation starting in Year 10. The exhaust fans are to be upgraded in Year 12.

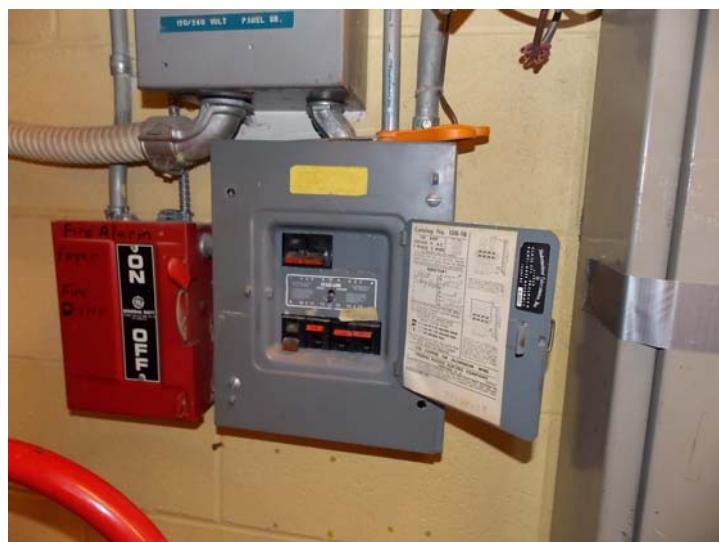
11. An original Federal Pacific circuit breaker panel (Stab-Lok model) is to be replaced in the first year of the plan. This type of

circuit breaker panel is a safety concern in that it has a history not reliably reacting to an electric overload condition. An allowance to upgrade the video monitoring system, public address system, and the central clock is Years 2, 9, and 16. The battery powered emergency lights are to be replaced in Years 7 and 17. The fire alarm system is to be upgraded in the second half of the plan in Year 12.

This FPE circuit breaker panel should be replaced in the near-term. These panels do not reliably react to electric overload conditions.
