# Capital Needs Assessment

Clark School

Amherst, NH

May 31, 2017

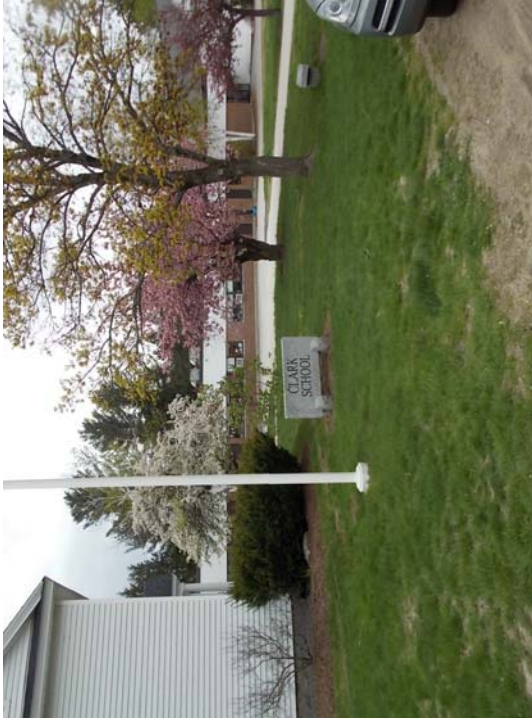
A view of the main entrance.

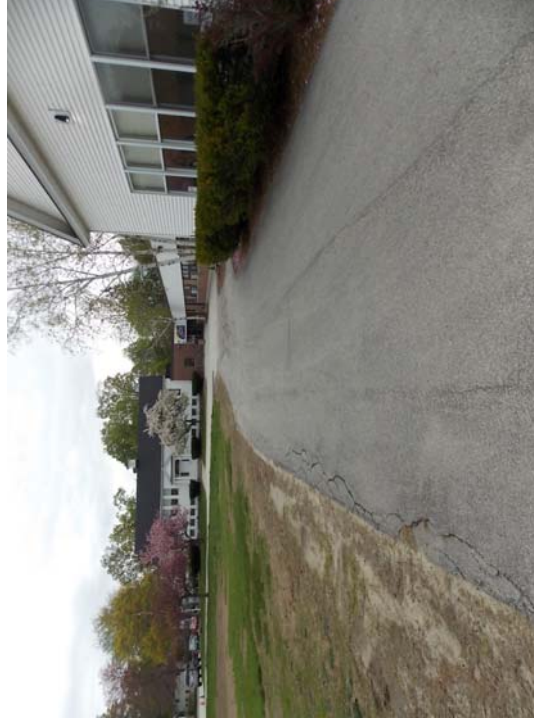
An elevation view with the recent building wing addition in the foreground on the right.

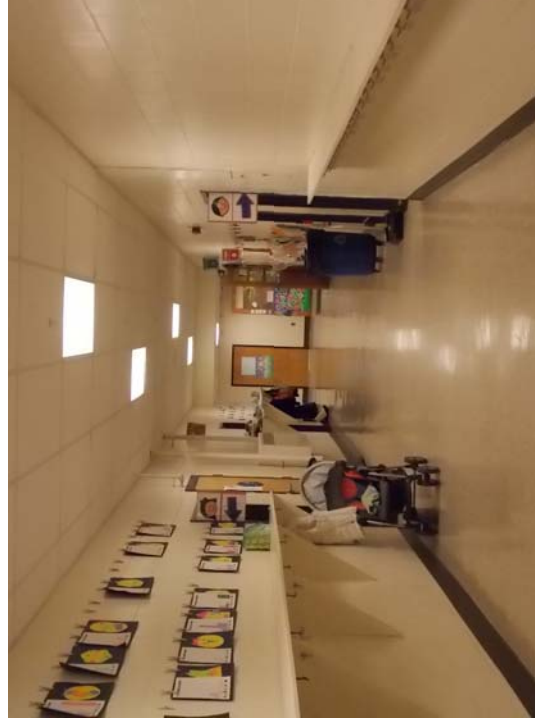
The main hallway has ceiling tiles, painted walls and VCT flooring.

17. Wall repainting and ceiling tile is shown every ten years starting in Year 7. Replacement of the vinyl composite tile (VCT) flooring is shown in Year 17. Also, allowances to replace classroom furnishings and equipment start in Year 5. Upgrade of the hallway shelving and coat hangers is shown in Years 7 and 17.

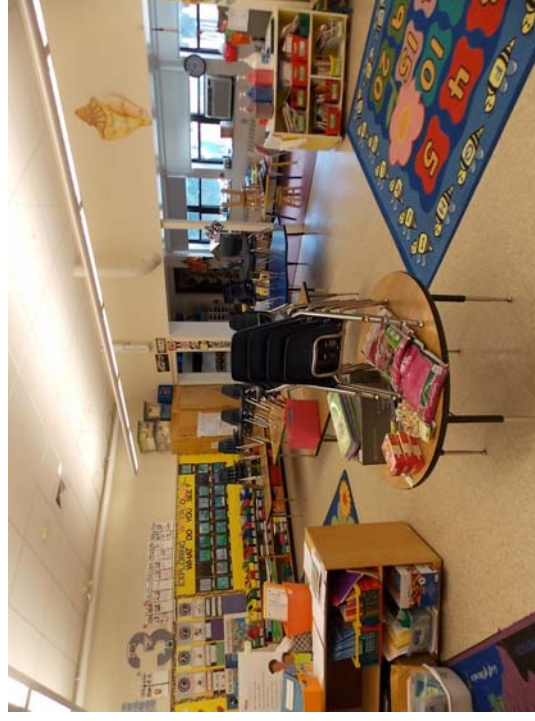
Classrooms also have ceiling tiles, painted walls and VCT flooring. Energy efficient fluorescent lighting (T8 lamps with electronic ballasts) are used throughout the facility.

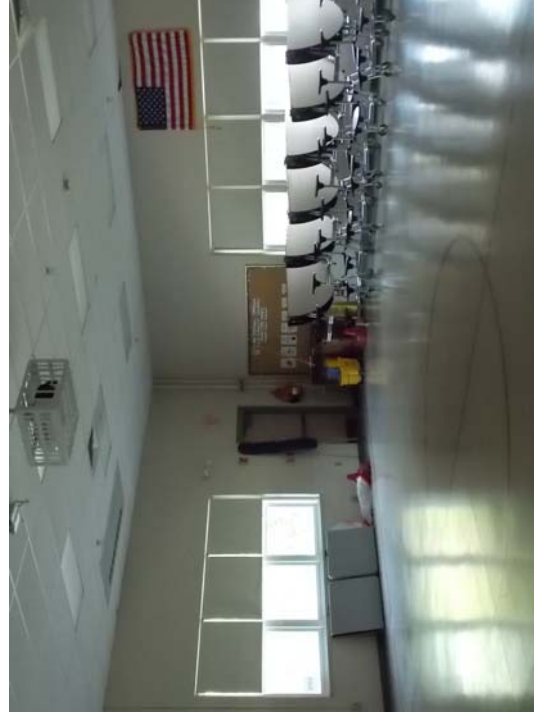
This is the recently added multipurpose room.

18. Replacement of ceiling tiles and repainting walls in the new building wing (Multipurpose Room and the Music/Arts Room are shown in Years 3 and 13.
- 19. Costs related to the school's support areas total \$86,798 or \$3.21 per square foot in inflated dollars.**

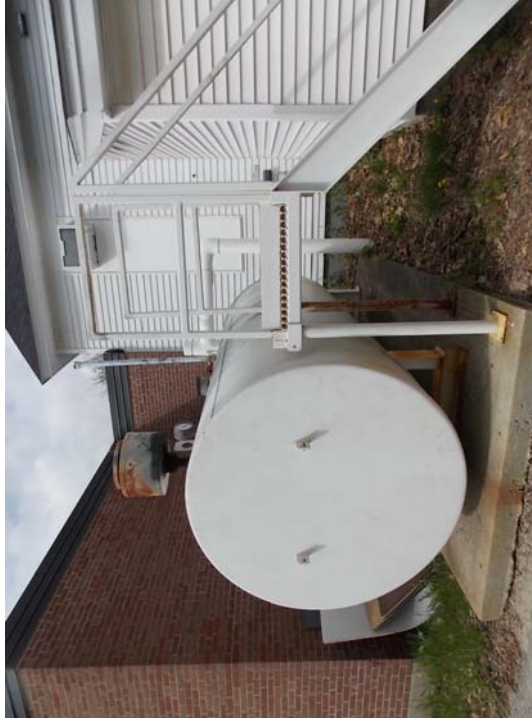
This is the above-ground double wall fuel oil storage tank.

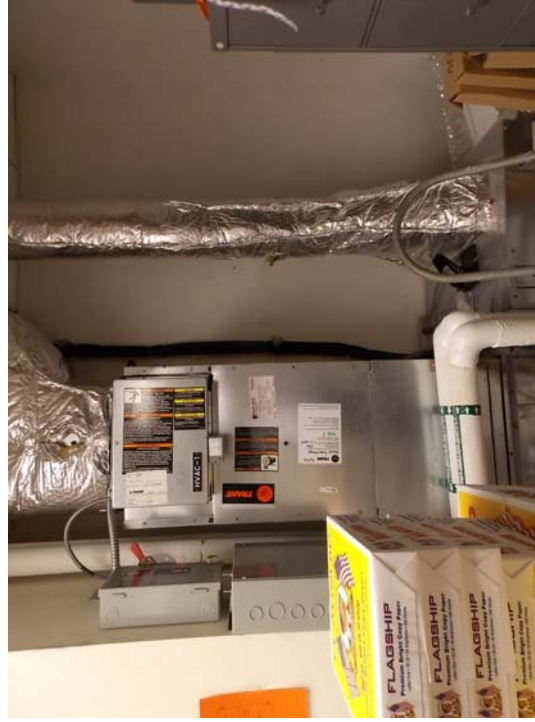
One of the air handlers.

7. An allowance for anticipated repairs to the baseboard finned tube starts in Year 6. The plan also includes the cost to replace the convectors in Year 12, and the costs to replace packaged air conditioner and the air handlers in Year 13. The rooftop mounted energy ventilation (air-to-air heat exchangers) are to be replaced in Year 18.

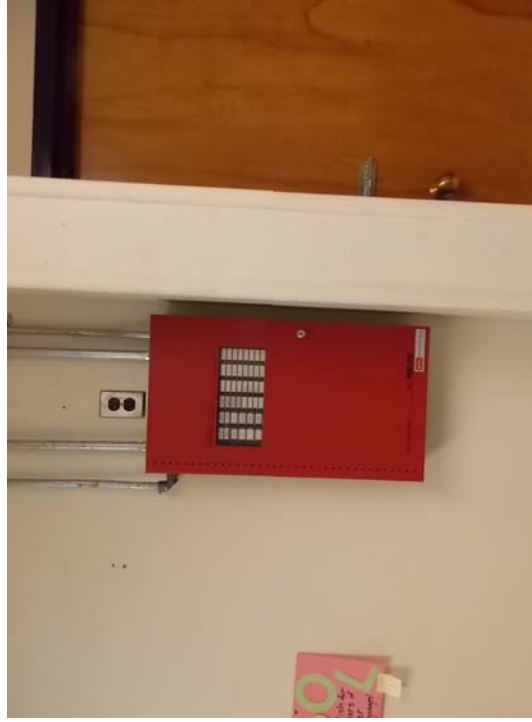
A view of the fire alarm control panel (FACP).
